MISCELLANEOUS PAPER NO. 6-760

SONISCOPE SURVEY, PAD 39-A CAPE KENNEDY, FLORIDA

H. T. Thornton, Jr.

November 1965

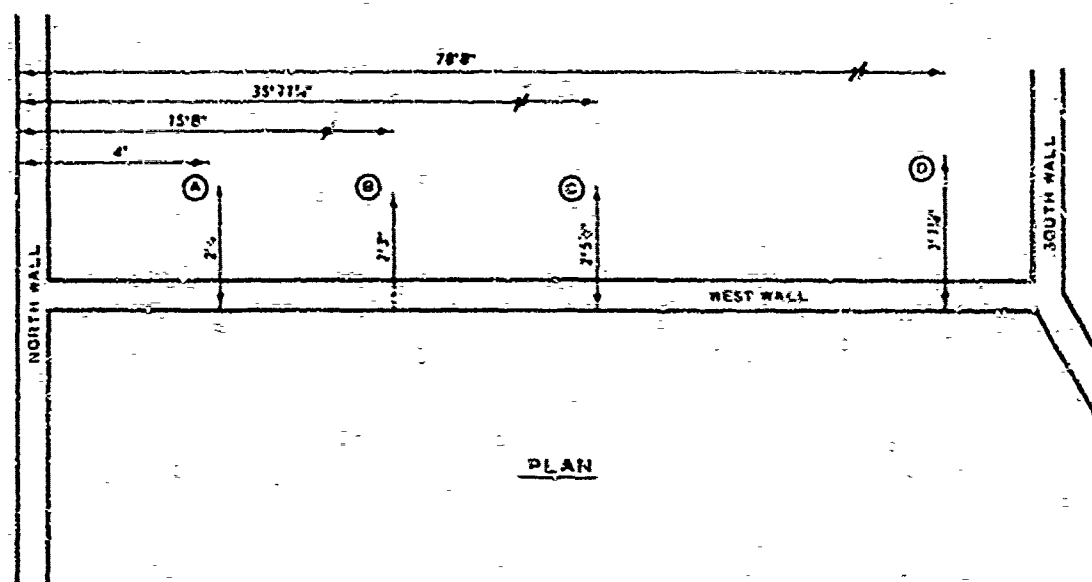
Fig. 1. Station locations on roof of ECS building

6. Roof adjacent to west wall of ECS building. Fill dirt was excavated from the roof at four sites adjacent to the west wall. Stations A, B, C, and D were located on the topside of the roof, one at each of the four excavated sites. Stations bearing the same letters (A, B, C, and D) were then located on the underside of the roof directly beneath the four stations on the top. From each of these stations on the underside of the roof, an array of points was established and numbered for the purpose of exploring the surrounding concrete with a series of diagonal measurements from the station on top to the station and points underneath. Fig. 1 shows the location of the four stations on the

rooftop. Plates 5, 6, 7, and 8 show the locations of points around each of stations A, B, C, and D on the underside of the roof. These plates also give the results of tests at each of the four sites. There was no apparent cracking in the vicinities of stations A and D, nor did the velocity measurements reveal anything unusual. The areas around stations B and C did show some cracking, and the results obtained at these two sites are discussed below.

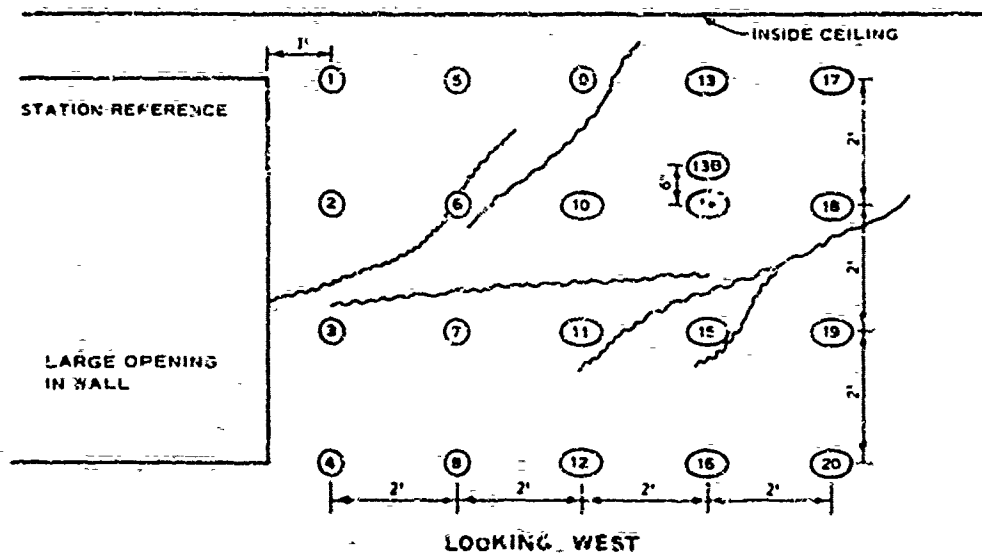
- b. Just south of area discussed above. A total of 36 measurements were taken in this area (plate 2). Six of these were taken straight through the wall, and 30 were taken diagonally from stations on the west face to stations on the east face. The six straight-through readings averaged 15,400 fps. Most of the diagonal readings were taken through cracked areas and consequently showed velocities below 15,400 fps. However, since only six velocities were below 13,000 fps and the lowest of these was 10,295 fps, the effect of cracking on velocity in this area does not seem to be drastic. Three of the stations on the west face of the wall were located in patched areas, but the patches seemed to have very little, if any, effect on velocities. Results of tests in this area are given in plate 2.

STATION NUMBER	PATH LENGTH, FT	VELOCITY, FPS	DIRECTION OF READINGS THROUGH WALL	STATION NUMBER	PATH LENGTH, FT	VELOCITY, FPS	DIRECTION OF READINGS THROUGH WALL
1 TO 1A	1.50	14,705	STRAIGHT	9A TO 11	4.27	13,555	DIAGONAL*
1A TO 2	2.50	15,150	DIAGONAL	9A TO 12	6.18	13,735	DIAGONAL
1A TO 3	4.27	14,675	DIAGONAL*	9A TO 4	7.31	14,390	DIAGONAL*
1A TO 4	6.18	14,610	DIAGONAL*	9A TO 5	4.75	14,845	DIAGONAL*
1A TO 5	2.50	13,890	DIAGONAL	9A TO 20	7.31	10,295	DIAGONAL*
1A TO 6	3.17	14,090	DIAGONAL*	9A TO 18	4.75	12,180	DIAGONAL*
1A TO 7	4.71	11,555	DIAGONAL*	13 TO 13A	1.50	15,625	STRAIGHT
1A TO 8	6.32	13,960	DIAGONAL*	13A TO 14	2.50	14,705	DIAGONAL
5 TO 5A	1.50	14,850	STRAIGHT	13A TO 15	4.27	13,345	DIAGONAL*
5A TO 6	2.50	14,535	DIAGONAL*	13A TO 16	6.18	14,045	DIAGONAL*
5A TO 7	4.27	13,430	DIAGONAL*	13B TO 13B	4.75	11,390	DIAGONAL*
5A TO 8	6.18	13,675	DIAGONAL*	15 TO 17A	1.50	16,130	STRAIGHT
5A TO 9	2.50	14,795	DIAGONAL	15 TO 17A	1.50	15,955	STRAIGHT

5A TO 10	3.17	11,125	DIAGONAL*	17A TO 18	2.50	14,705	DIAGONAL
5A TO 11	4.71	12,695	DIAGONAL*	17A TO 19	4.27	14,140	DIAGONAL*
5A TO 12	6.32	13,470	DIAGONAL*	17A TO 20	6.18	14,475	DIAGONAL*
9 TO 9A	1.50	15,150	STRAIGHT	17A TO 15	4.75	14,395	DIAGONAL*
9A TO 10	2.50	14,535	DIAGONAL*	17A TO 16	6.32	14,620	DIAGONAL*

STATION LOCATION AND
PULSE VELOCITY DATA,
WEST WALL JUST SOUTH
OF AREA IN PLATE I
ECS BUILDING

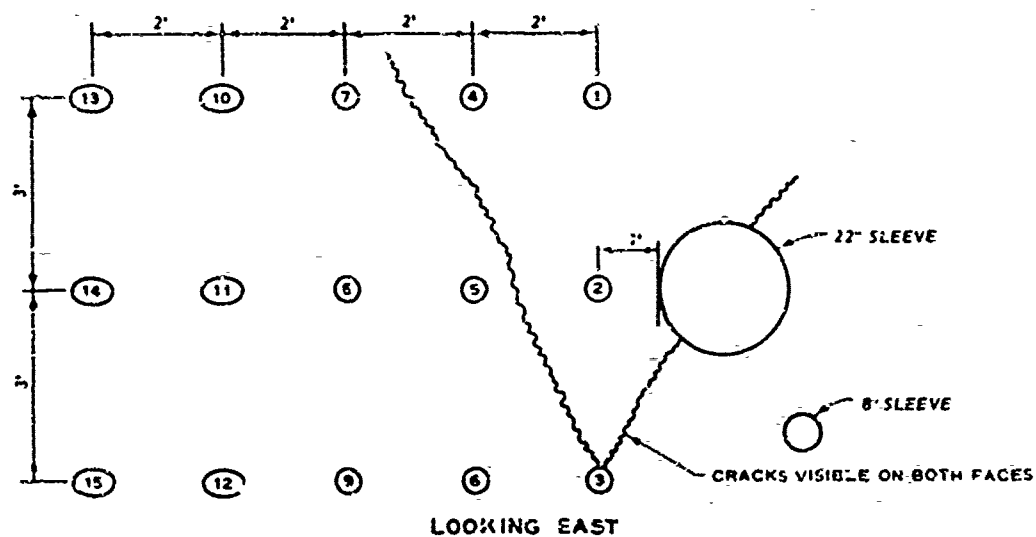
STATION NUMBER	PATH LENGTH, FT	VELOCITY, FPS	REMARKS	STATION NUMBER	PATH LENGTH, FT	VELOCITY FPS	REMARKS
1 TO 1A	1.50	14,425	*	10 TO 10A	1.50	14,850	*
2 TO 2A	1.50	14,705	*	11 TO 11A	1.50	14,285	*
3 TO 3A	1.50	14,235	*	12 TO 12A	1.50	15,150	*
4 TO 4A	1.50	14,285	*	7 TO 7A	2.50	14,705	**
5 TO 5A	1.50	14,150	*	8 TO 8A	5.22	14,540	**
6 TO 6A	1.50	14,130	*	9 TO 9A	5.22	13,975	**
2 TO 4A	3.96	15,115	**	7A TO 11	3.96	15,470	**
2 TO 6A	1.96	13,800	**	9A TO 11	3.96	14,045	**
3 TO 4A	0.50	14,190	**	13 TO 13A	1.50	15,305	*
3 TO 5A	3.96	13,945	**	14 TO 14A	1.50	14,285	*
1A TO 6	5.50	14,410	**	15 TO 15A	1.50	14,850	*
1A TO 5	3.96	15,035	**	11 TO 13A	3.96	15,590	**
2 TO 5A	2.50	14,490	**	11 TO 14A	2.50	14,535	**
7 TO 7A	1.50	14,850	*	11 TO 15A	3.96	14,245	**
8 TO 8A	1.50	14,285	*	1 TO 15A	10.00	13,985	**
9 TO 9A	1.50	14,705	*	3 TO 13A	10.00	11,910	**

STATION LOCATION AND
PULSE VELOCITY DATA,
SOUTH END OF WEST WALL
EGS BUILDING

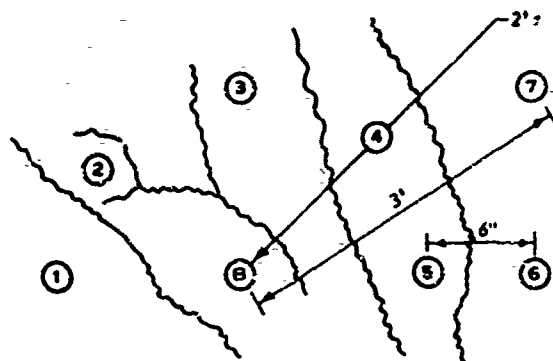
PLATE :

- a. Station B. The roof in the vicinity of station B was cracked in several places (plate 6). The straight-through reading showed a velocity of 16,665 fps. The remaining seven readings produced velocities between 15,285 and 12,415 fps. Lower readings were obtained as the number of cracks in the path of the signal increased.
- b. Station C. There was only one visible crack in the vicinity of station C (plate 7). The four velocities which were significantly lower than the others were apparently affected by this crack. The remaining velocities in this area were uniform, and nothing unusual was indicated.

STATION NUMBER	PATH LENGTH, FT	VELOCITY FPS	REMARKS
B TO B	2.50	16,665	*
B TO 1	3.24	15,285	**†
B TO 2	3.24	15,140	**†
B TO 3	3.24	15,285	**†
B TO 4	3.24	13,555	**††
B TO 5	3.24	13,445	**††
B TO 6	3.54	12,510	**‡
B TO 7	3.91	12,415	**‡

STATION LOCATION AND
PULSE VELOCITY DATA,
STATION B ON ROOF
ECS BUILDING

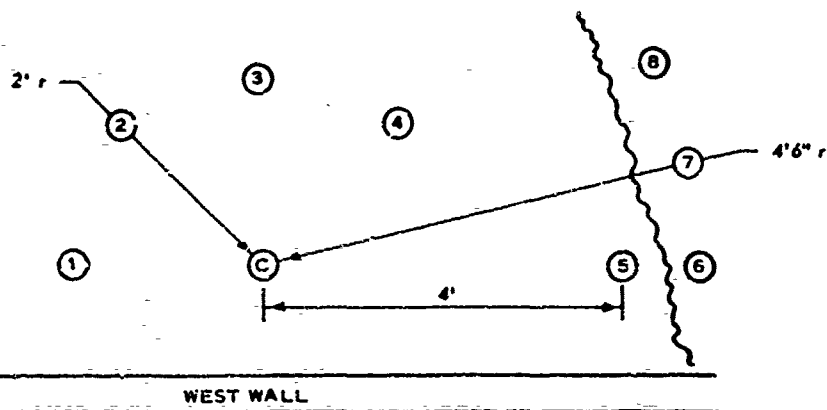
PLATE 7

STATION NUMBER	PATH LENGTH, FT	VELOCITY, FPS	REMARKS
C TO C	2.50	15,925	•
C TO 1	3.24	15,355	••
C TO 2	3.24	15,140	••
C TO 3	3.24	15,140	••
C TO 4	3.24	15,355	••
C TO 5	4.72	13,300	••
C TO 6	5.15	13,995	••†
C TO 7	5.15	14,070	••†
C TO 8	5.15	13,805	••†

STATION LOCATION AND
PULSE VELOCITY DATA,
STATION C ON ROOF
ECS BUILDING
